Region 9 Enforcement Division
75 Hawthorne Street
San Francisco, CA 94105

Inspection Date(s):	9/29/2015		
Time:	Entry: 9:00 am	Exit: 10:00am	
Media:	Water		
Regulatory Program(s)	Clean Water Act NPDES /CAFO Dairy		
Company Name:	Bosch Dairy No. 2		
Facility or Site Name:			
Facility/Site Physical Location:	Ex. 6 Personal Privacy (PP)		
Geographic Coordinates:			
Mailing address:			
Facility/Site Contact:	Bernard Bosch	Title: Operator	
	Phone: Ex. 6 Personal Privacy (PP)	Email:	
Facility/Site Identifier:	NPDES CAG018001 / Order R8-2013-0001, General waste discharge requirements for CAFOs (dairies and related facilities)		
NAICS:	112120 Dairy Cattle and Milk Production		
SIC:	0241 Dairy Farms		
Facility/Site Personnel Participating in Inspection:			
Name	Affiliation	Title	Email
Bernard Bosch		Operator	
EPA Inspector(s):			
John Tinger	EPA	Engineer	Tinger.John@EPA.gov
Federal/State/Tribal/Local Representatives:			
Edward Kashak	WRCB-R8	Engineering Geologist	ekashak@waterboards.ca.gov

The purpose of the inspection was to ensure compliance with the NPDES permit and applicable Federal regulations covering the discharge of wastewaters into waters of the United States.

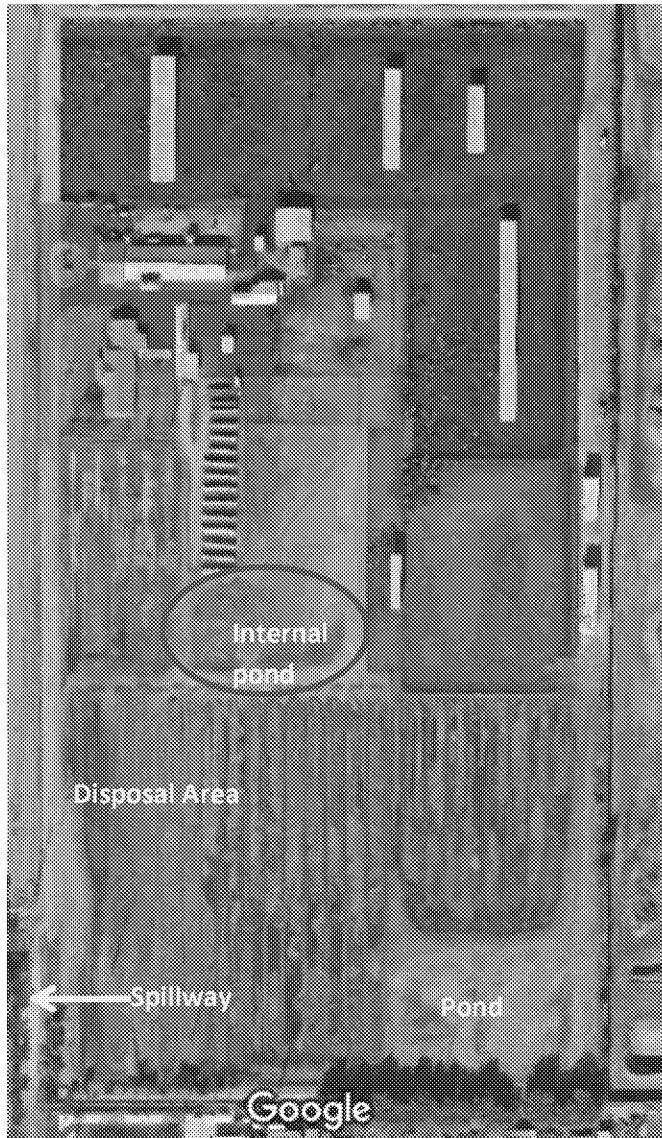
Stormwater generally flows in a southerly direction (see photo 1). Stormwater from the central/eastern portion of the facility first flows to the pond located in the center of the facility, and then may sheet flow to the disposal area and then to the pond in the south eastern portion of the facility.

Photo 1: Facility overview google earth.

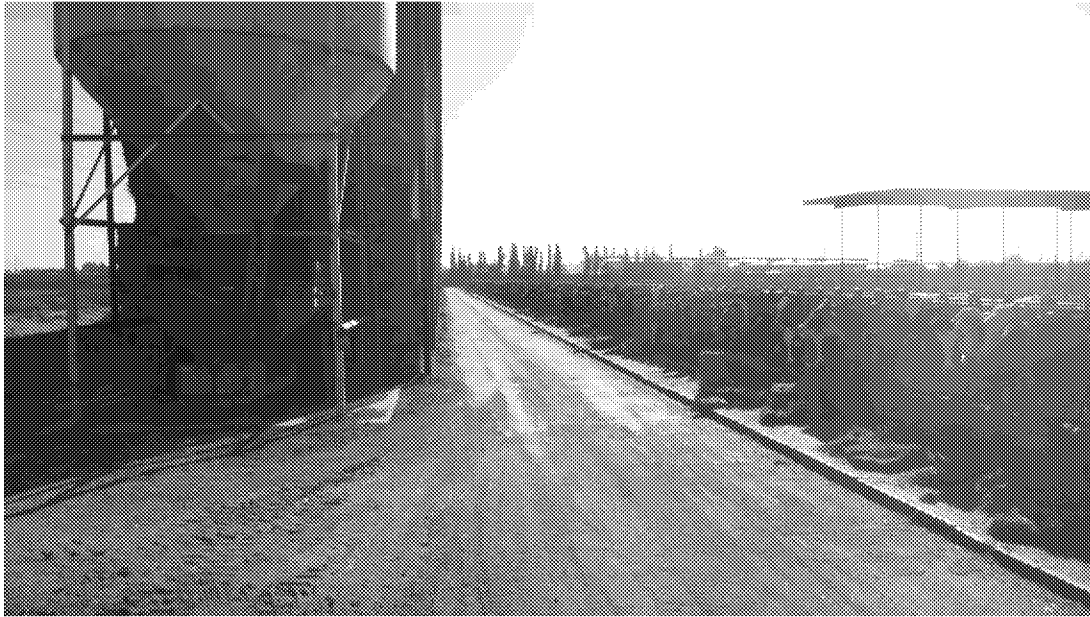
Photo 2: northern boundary of facility looking west.

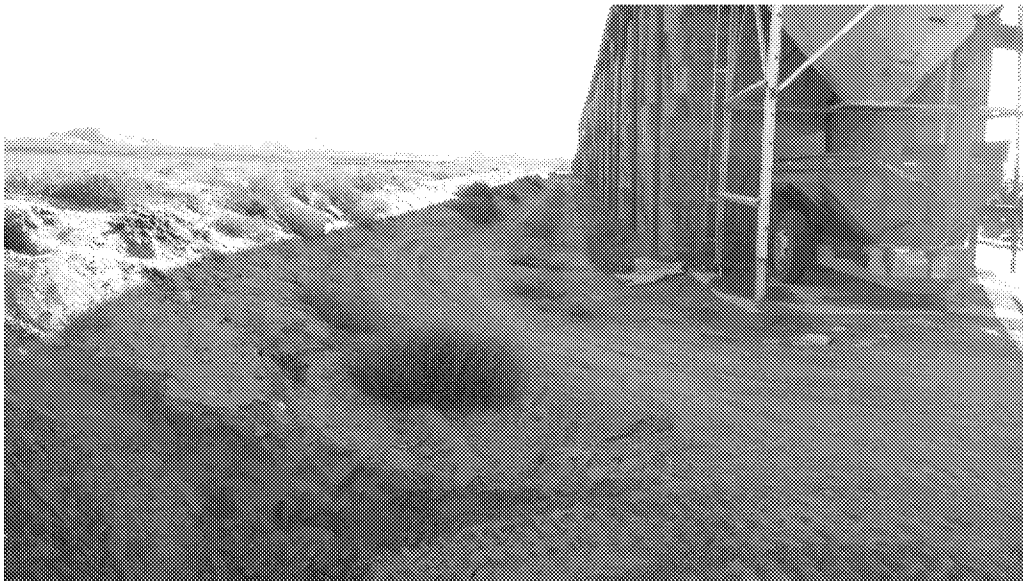
Photo 3: Pit dug in northwest section of facility to prevent discharge of feed materials onto roadway.

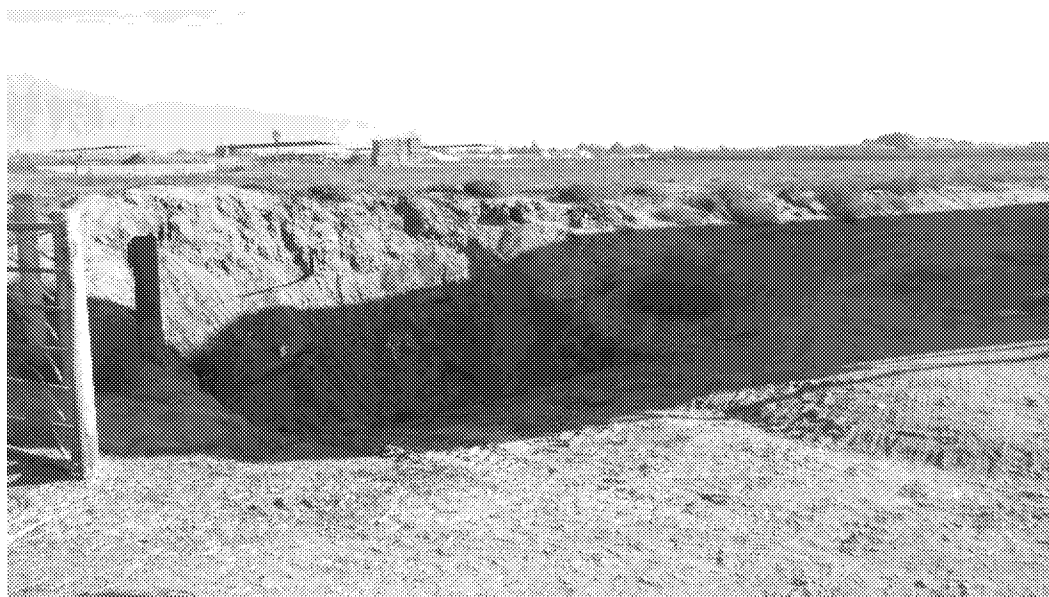
Photo 3: Pit dug in northwest section of facility to prevent discharge of feed materials onto roadway.

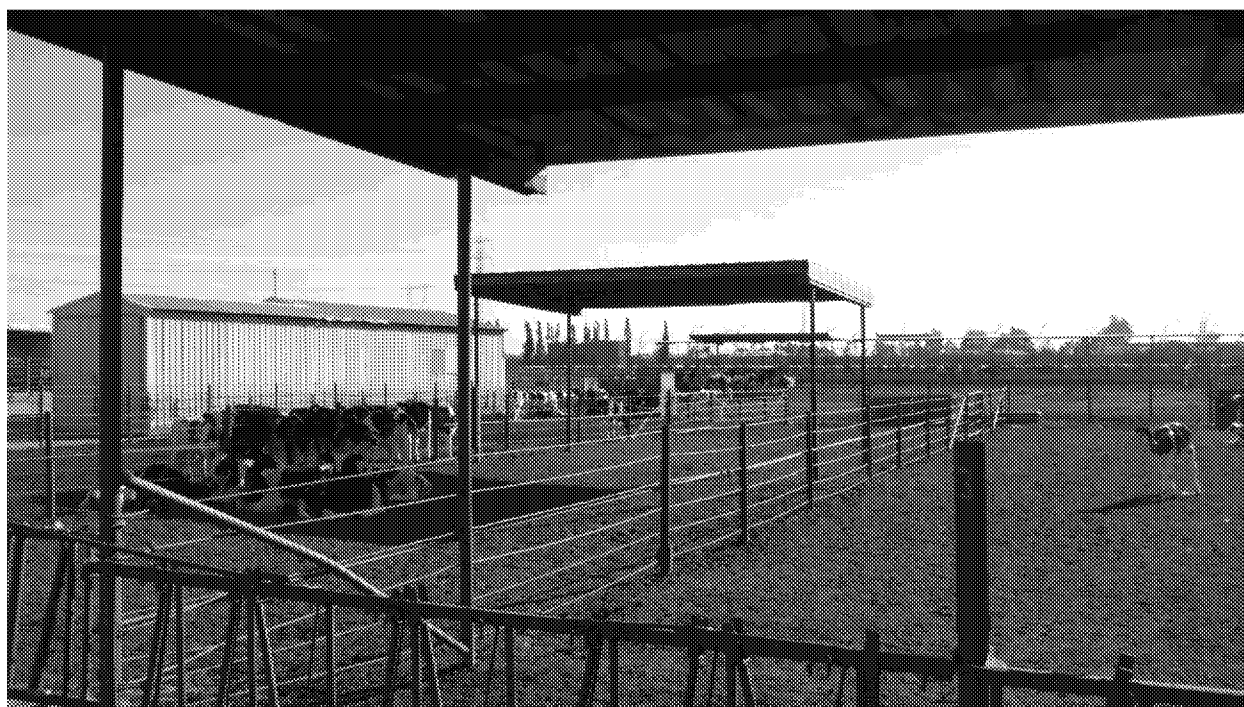
TYPICAL DEPTH OF MANURE IN CORRALS: < 6"

Photo 4: Corrals

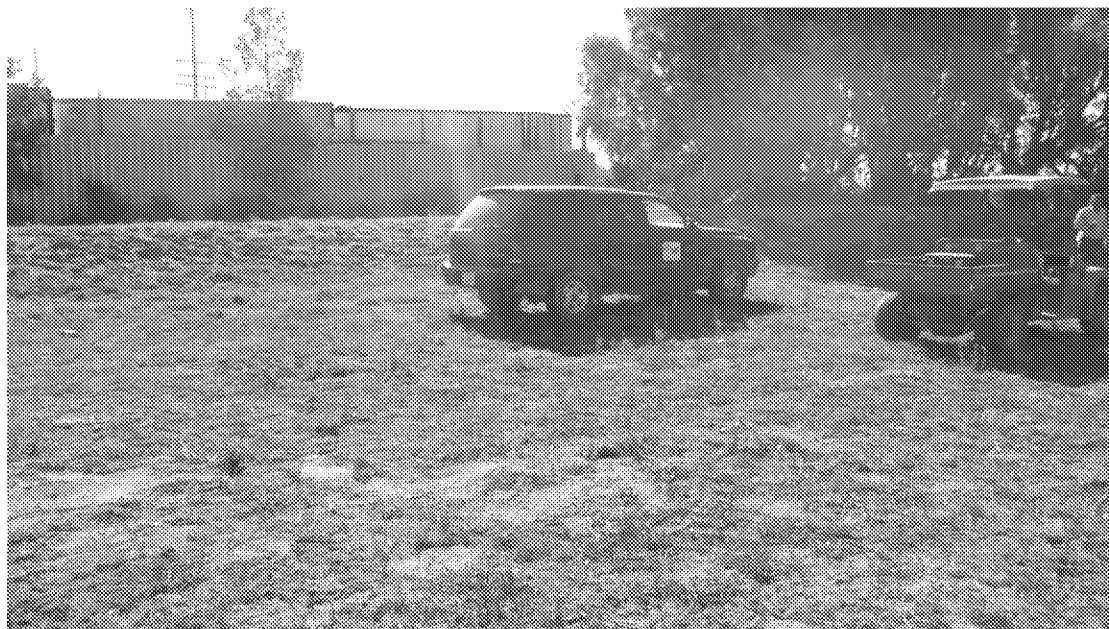
The southern ponds were dry. The operator did not know the last time solids were removed from the ponds. There was no evidence of accumulation of manure or solids in the southern ponds.

No evidence of significant rodent damage, erosion, or excess vegetation along berms was observed. Ponds generally clear of vegetation.

Photo 5: pond / berm at southeast corner of facility, looking southeast

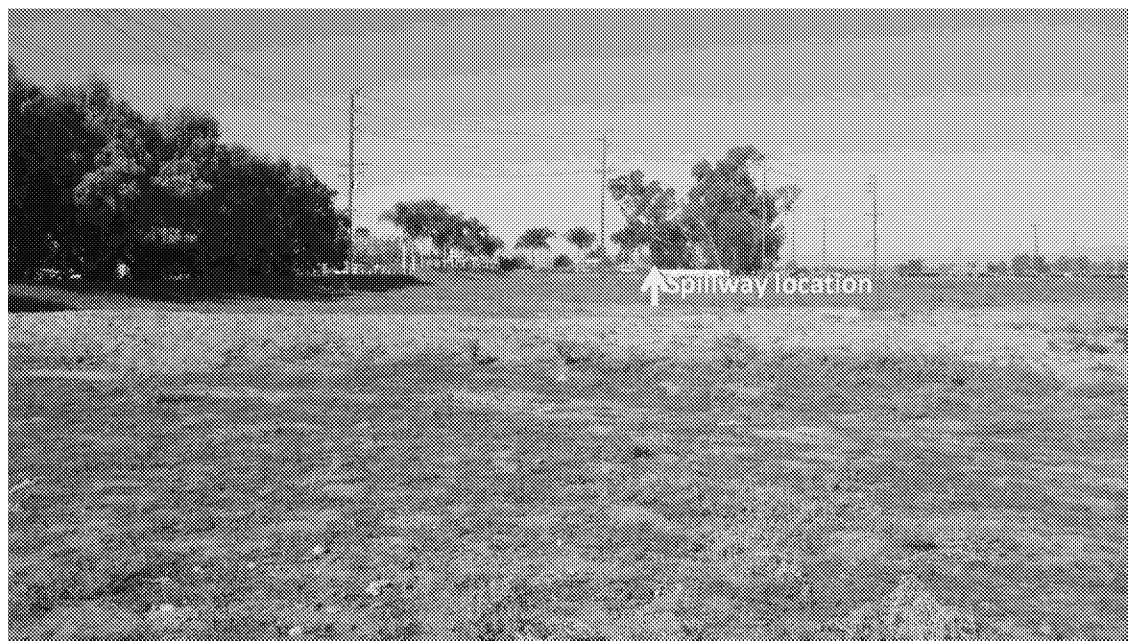
Photo 6: View of pond berm at southern edge of facility; looking west.

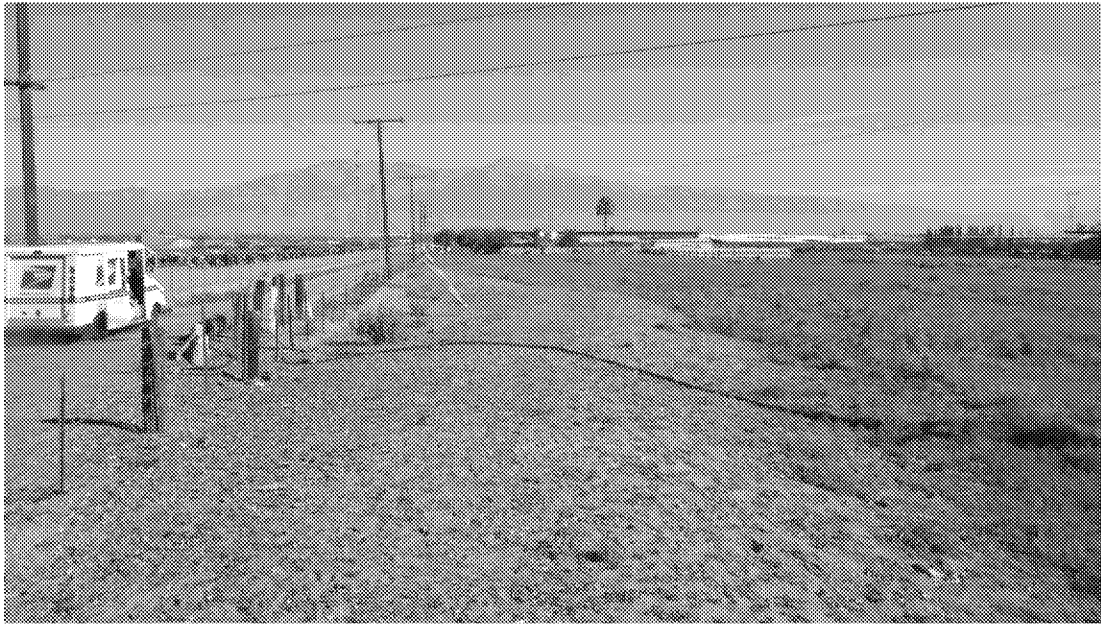
Photo 7: Berm along western edge of facility, looking north.

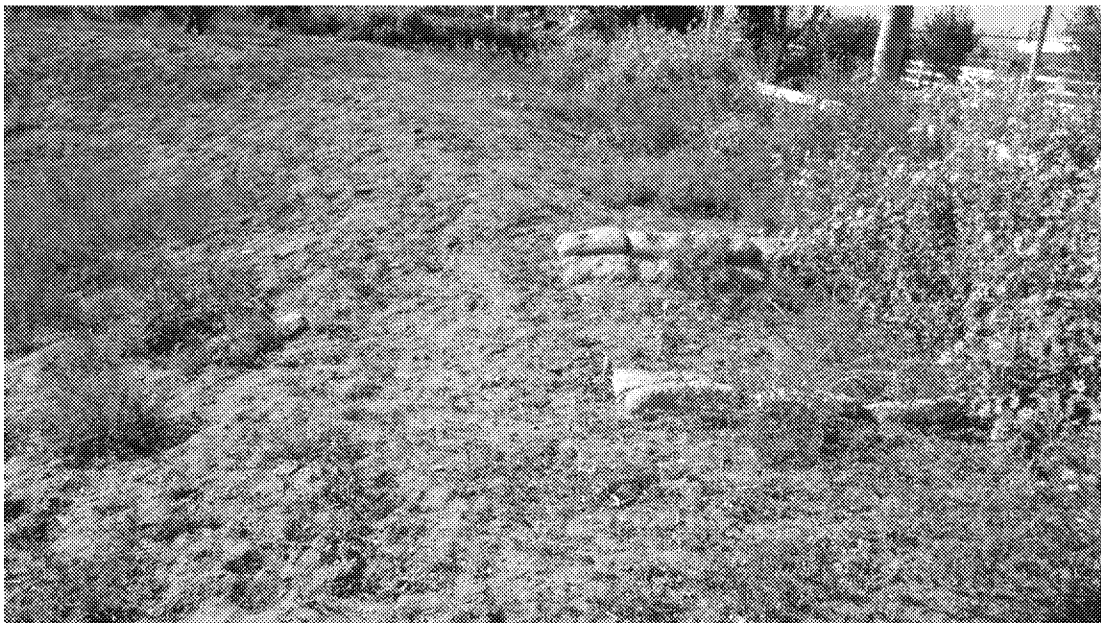
- The 2014 Manure Tracking Manifest and facility documentation did not appear to clearly document the destination of manure. Facility documentation of manure handling was not available on-site.
- The 2014 annual report did not contain nutrient analysis; the nutrient analysis was not available on-site.
- The concrete spillway had an accumulation of unconsolidated soil on top of the spillway which may block the spillway or cause erosion in event of overflow event.

Photo 8: Spillway; sediment accumulation on top of concrete.
